National Center for Hydrology and Meteorology  
Thimphu: Bhutan  
FLOOD STATUS #43

Update-04

Issue Date/time: 24<sup>th</sup> June, 2019/21:00 (valid until the next issuance)

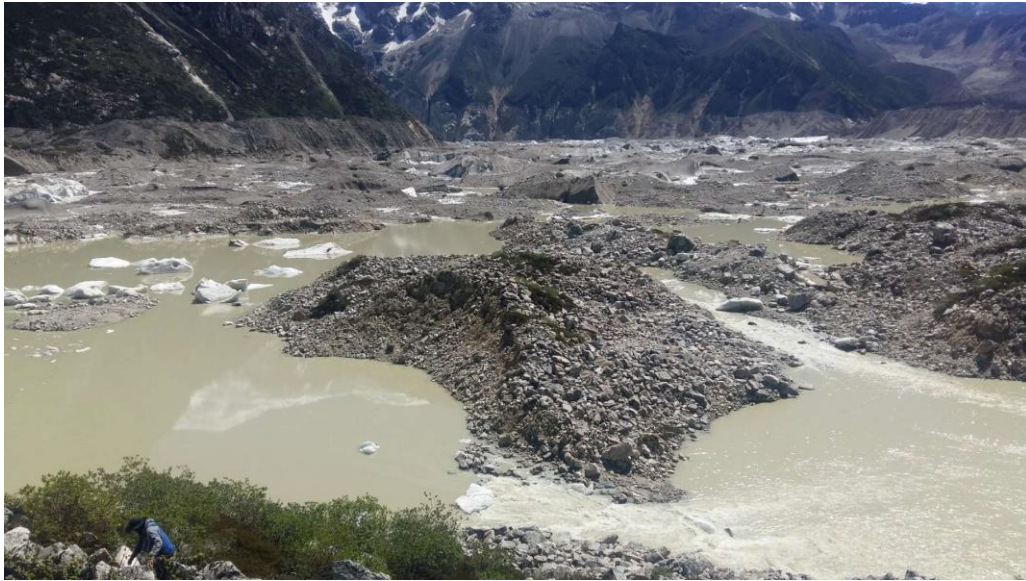
*Picture 1: View of the Thor Thormi Lake taken today 24/6/2019*

There is not much significant change in water level, however due to the breaching of subsidiary lake 2, the stability of moraine dam of the main Thorthormi Lake is likely to be more uncertain. Therefore, people living along the Phochu River and downstream are requested to be vigilant.

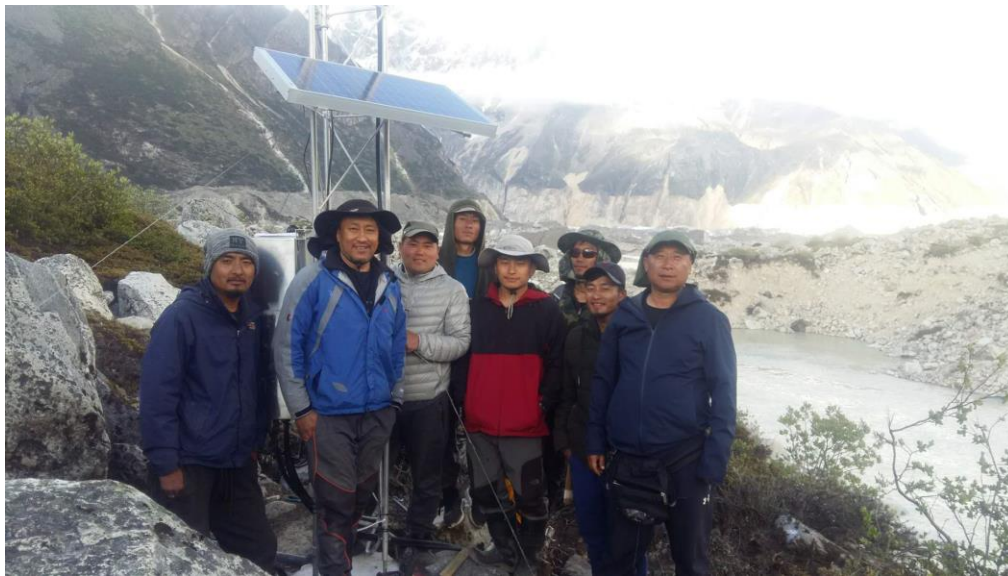
*Picture 2: Photo of NCHM Team and other support staff taken after successfully relocation of AWLS at Subsidiary lake 1 of Thor Thormi Lake (24/06/2-19)*

The damaged Automatic Water Level Station (AWLS) on Thorthormi Lake located on the Subsidiary Lake 2 was relocated to Subsidiary Lake 1. The reinstallation work of AWLS on Thorthormi lake was successfully completed today (24 June 2019) evening by the NCHM team with the support from Principal and teachers from Lhedi Primary School and BHU staff. NCHM would like to thank Principal, teachers, Health Assistant (HA) and other staff for extending their support for immediate restoration of the AWLS. Thorthormi AWLS has started transmitting water level data automatically to Wangdi GLOF Control and NCHM HQ, Thimphu starting from 17:10 hours. Detail water levels are given below.
